The Fairmont Community Wildfire Protection Plan

AN ACTION PLAN FOR WILDFIRE MITIGATION

January 2013

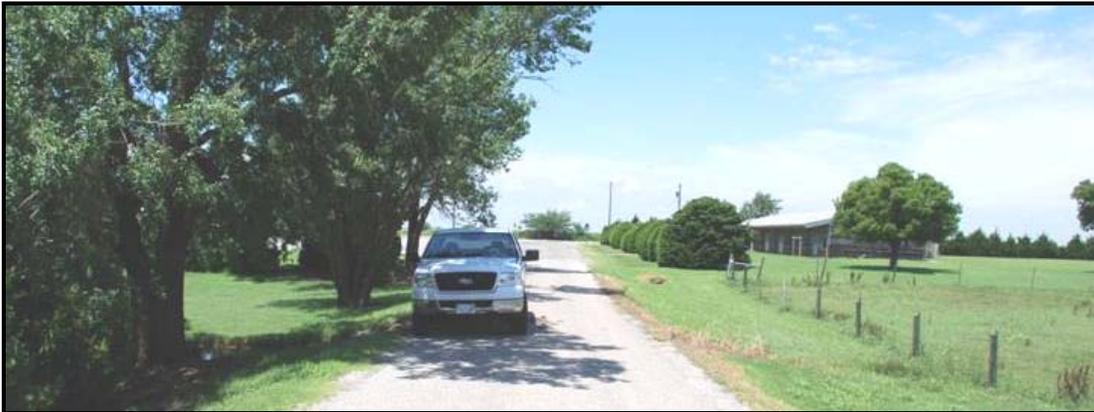
Ingress/Egress: Most of Fairmont (Area 1) has at least two streets coming in and out of the residential area so access is very good, however some streets are too narrow for apparatus to pass each other. There are low and abundant tree branches on west Enid Street which hampers firefighting apparatus from using the most direct route to a fire.

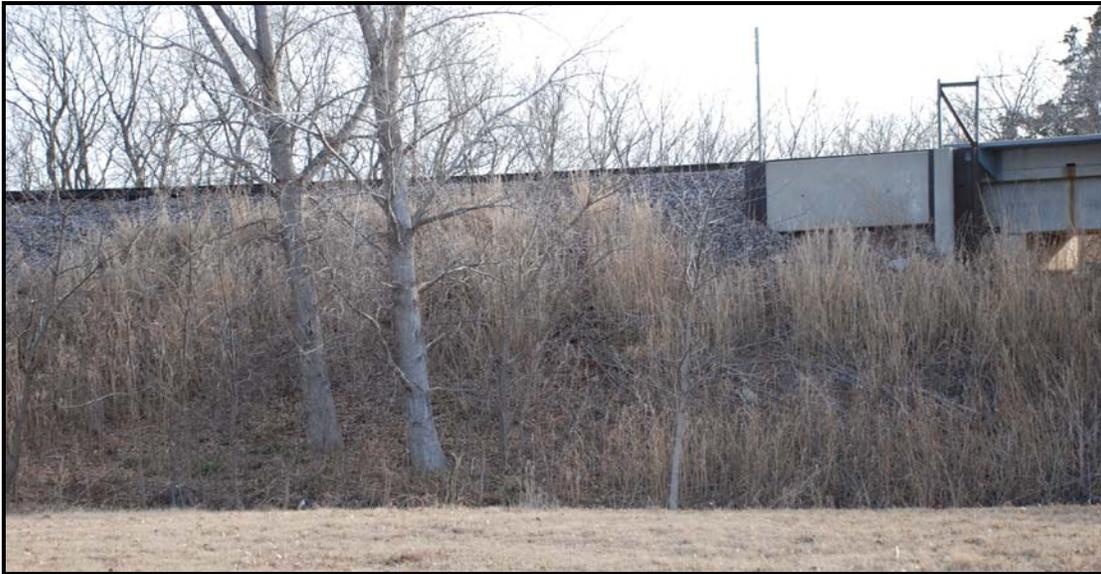
Fuel Load: During droughts and winter months when grass isn't growing there is a concern some dormant vegetation would be easy fuel for a fire to start or add to its spread, especially along the railroad tracks and pasture fence rows.

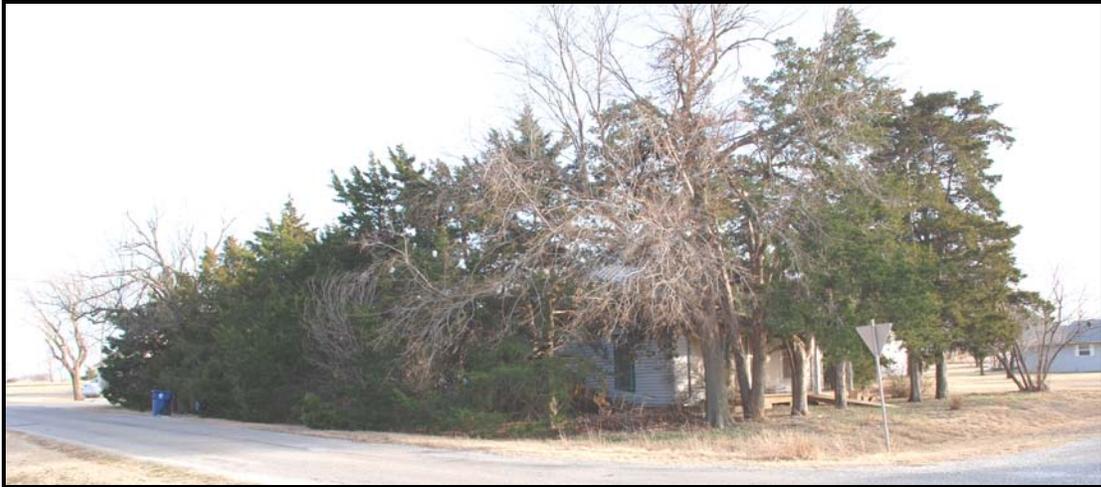
Defensible Space: As in many cities and towns, homes in the residential areas are not too close to neighbors, but a 30 foot defensible space is not always possible without encroaching on neighbors' property. Some homes have a good defensible space around them, but many need brush and weeds trimmed back or removed, along with some pruning on the trees.

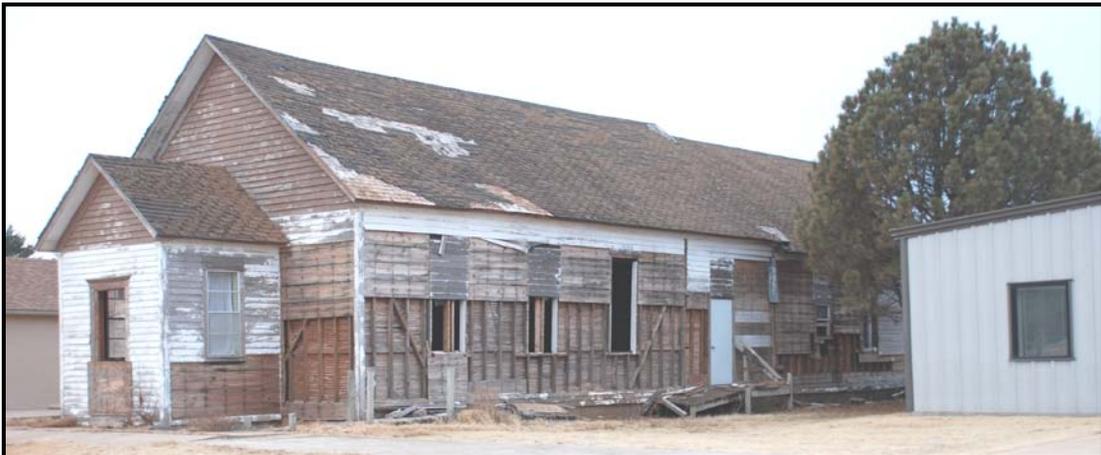
Most of the old Main Street business structures in Fairmont have been torn down and therefore do not have common walls to be a concern. The post office, town hall, and fire station are the staples now (no adjoining walls) with only a few old dilapidated structures left. The old wooden town hall (which was originally the Lutheran church) is still on Main Street and is a fire hazard to the post office and current town hall facilities.

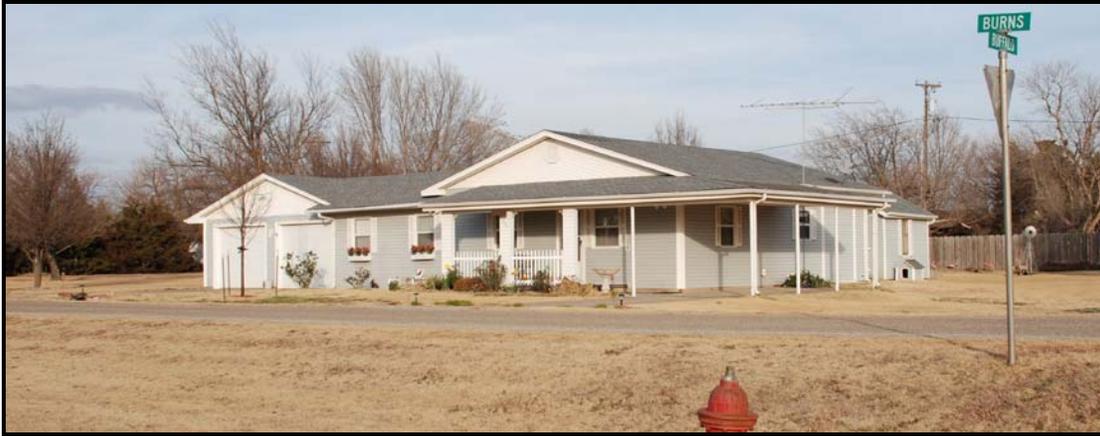
Building Materials: Most homes have metal or fire resistant shingles and many of the homes are built of brick or fire-resistant siding. Most if not all of the trailer houses had skirting to protect them from hot embers blowing underneath, but the porches and decks on homes and trailers need to have skirting to protect those homes.

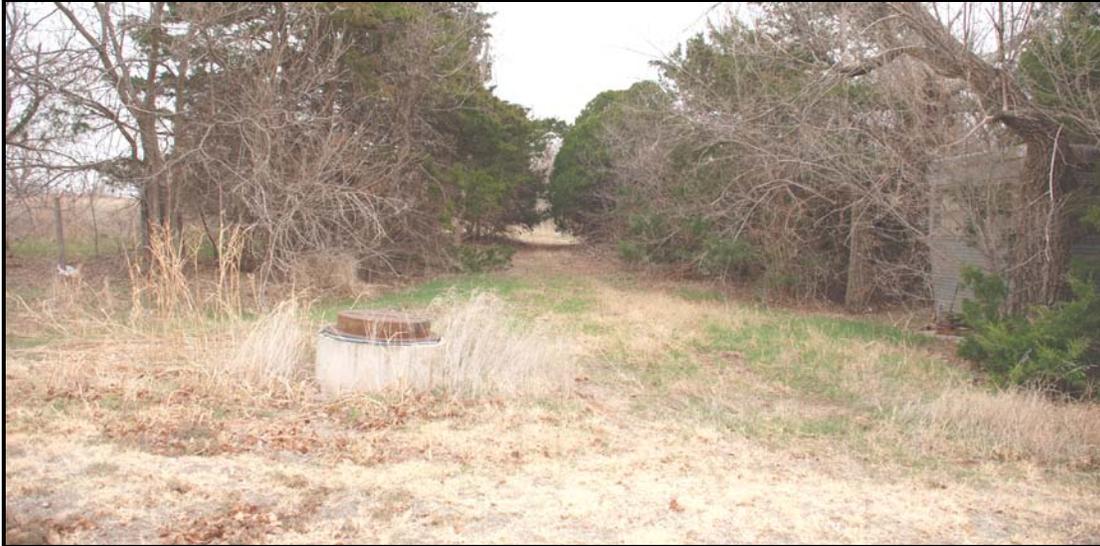
- Alleys need to be cleared of debris and overhanging branches for greater accessibility.

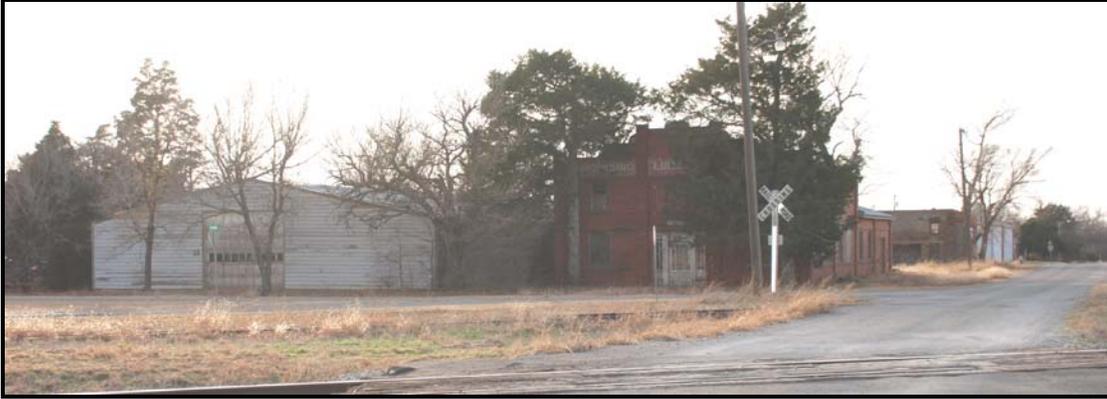
- Dilapidated buildings and houses pose a risk to neighbors as many have overgrown grasses, weeds and trees.
- Some historic brick buildings need to be cleared of vegetative overgrowth to help protect them from fires.

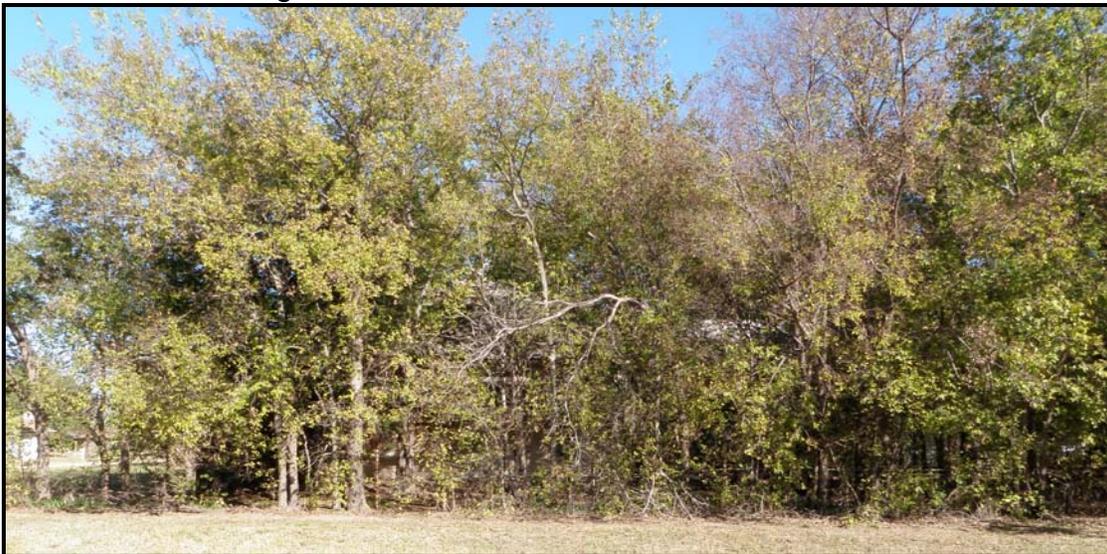
- Several propane tanks are located under or beside trees which increases the home's risk.
- Several houses along Patterson and Olive Sts. are surrounded by trees (including Eastern red cedar) that are not maintained and not only touch the house but are so thick they hide it. A fire at any of these locations would be a total loss to the house almost immediately and neighboring houses would be in immediate danger.

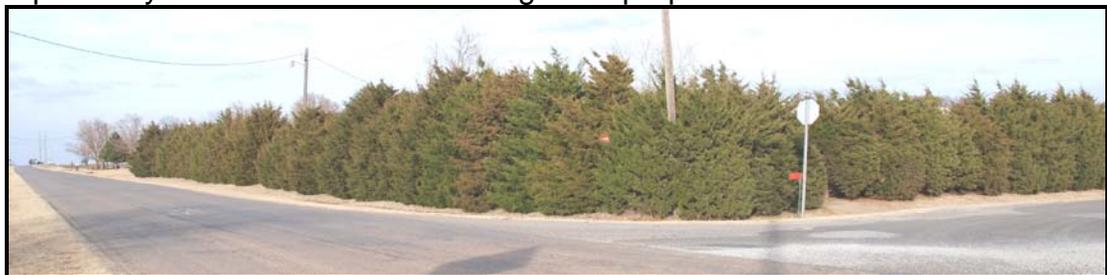
- The church and property has cedar trees with branches on the ground along 2-3 sides. This also creates a blind corner for vehicles pulling onto Fairmont Road. If a fire gets in those the church would be at a great risk due to the proximity of the trees to the buildings and propane tanks.

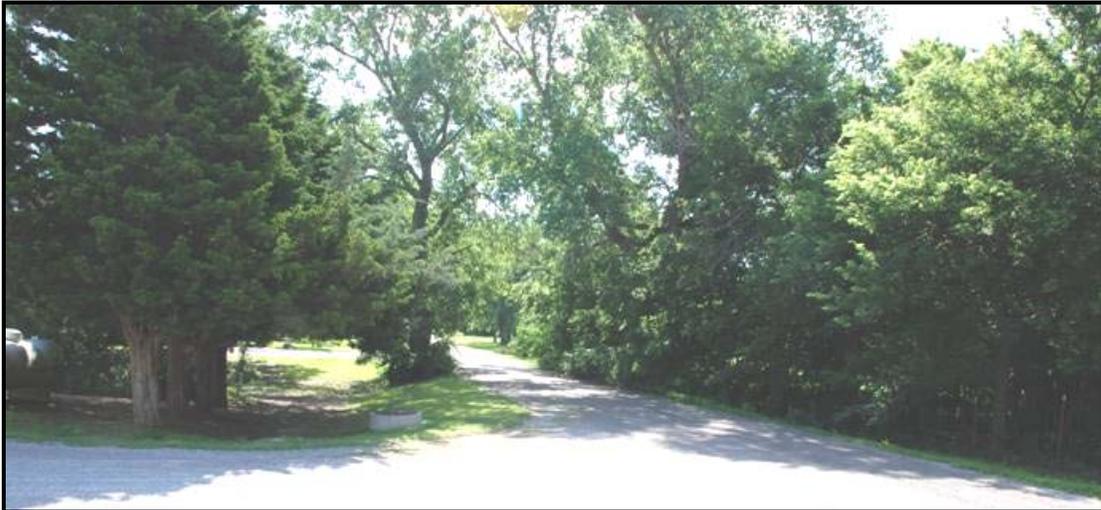
- Enid Street needs trees pruned up and away from the street to allow for safer apparatus movement.

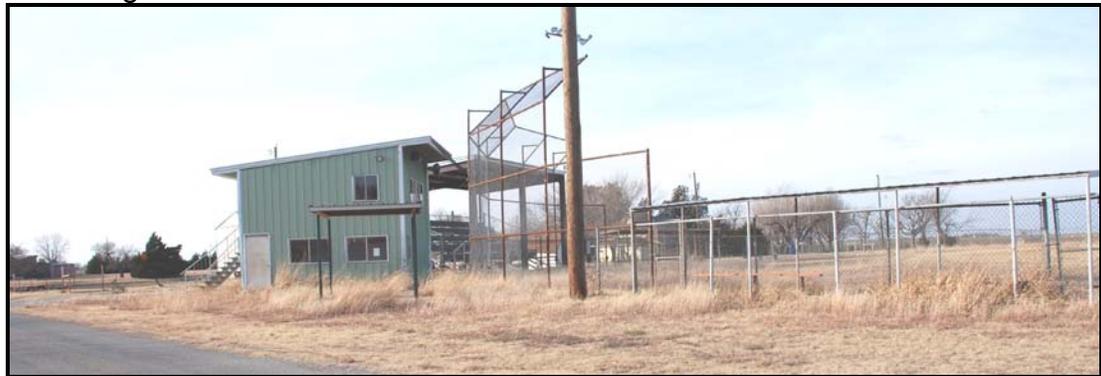
- The block south of the ball park is very overgrown with trees and needs regular maintenance by the landowner(s). The ball park also needs regular mowing.

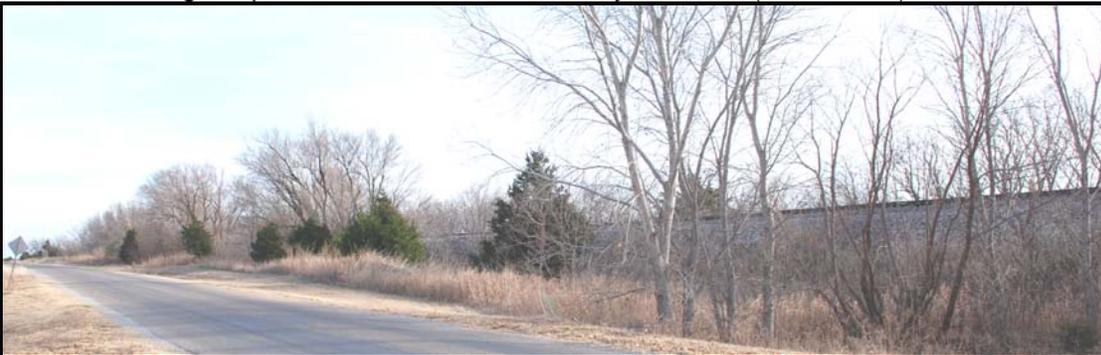
- The railroad underpass trellis bridge on 114th/Fairmont Road has a clearance height of 13'6" which could be an issue for some firefighting apparatus. None of Fairmont FD's equipment is taller than that, but other responding fire departments may have some.
- The railroads could be a problem prior to, during and after harvest when surrounding crop fields have increased dry stubble (ie fire fuel).
