The Fairmont Community Wildfire Protection Plan

AN ACTION PLAN FOR WILDFIRE MITIGATION

January 2013

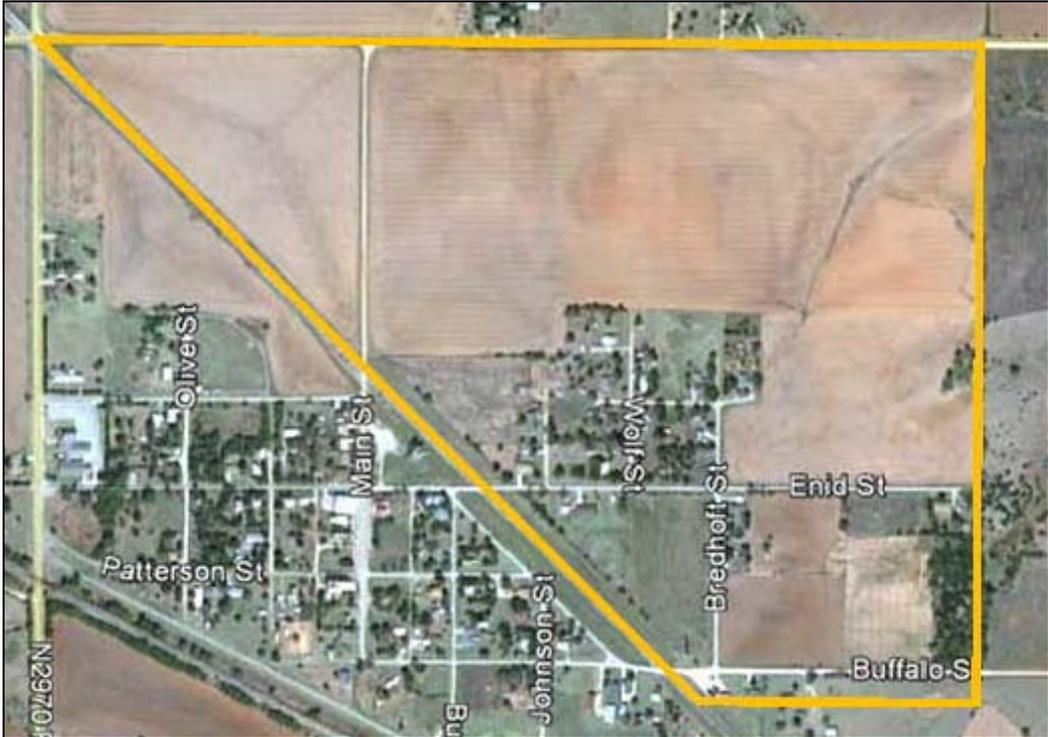
Areas of Concern

- Fields south of the railroad tracks/town and southeast and west of town are an increased risk from late May through late August due to the no-till farming practices utilized (sprayed to kill summer growth and not worked up so fire fuel is on the ground longer).
- More farmers around Fairmont are utilizing "prescribed" burn practices which increases the risk of a wildfire when not prepared or conducted correctly.
- Although there are two roads into Area 2, there is limited access because the railroad tracks cross both roads and trains easily block both intersections (majority of trains are one mile in length or longer).
- The home at the east end of Enid Street has only one exit and has natural landscaping south of it.
- Area 2 has larger lots and fewer dilapidated houses, but it also has larger open areas and natural landscaping.

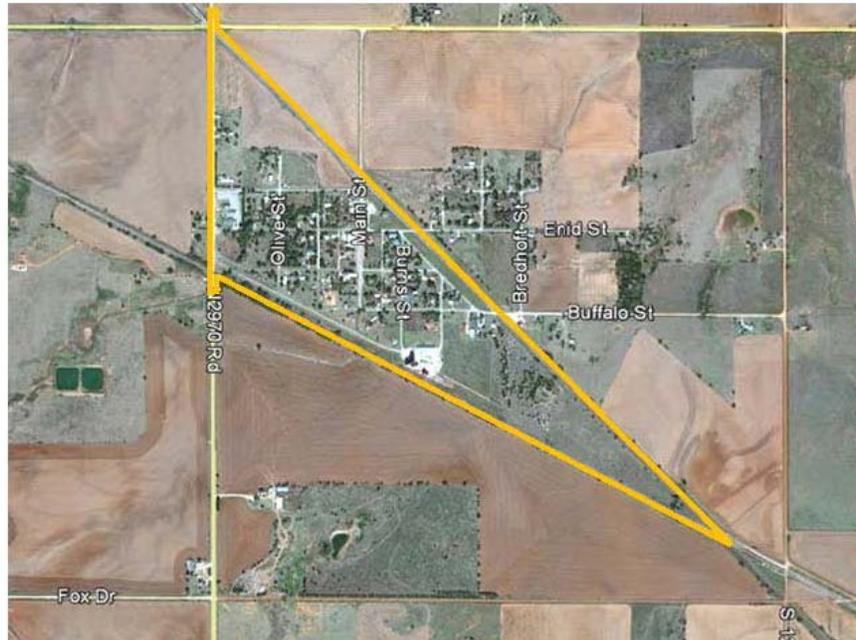
Alleys need to be cleared of debris and overhanging branches; dilapidated buildings and house

The farm south of the western RR tracks is an increased risk from late May through July due to the farming practices (sprayed to kill summer growth and not worked up so fire fuel is on the ground longer). More farmers around Fairmont are utilizing prescribed burn practice which increases the risk of a wildfire when not done correctly.

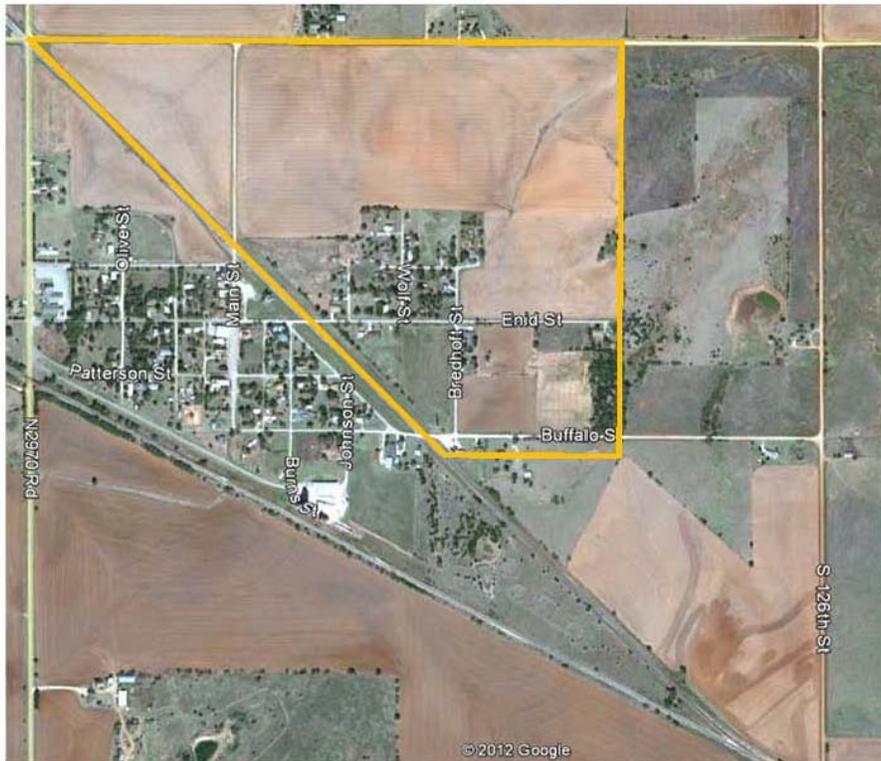
Although there are 2 roads into this area, there is limited access because the railroad tracks cross both roads and trains can easily block both intersections (majority of trains are 1 mile in length or longer). Also, the home at the east end of Enid Street has only one exit and has natural landscaping south of it.
